NASA Technical Memorandum 81432

APPLICATION OF COMPOSITE  
MATERIALS TO TURBOFAN  
ENGINE FAN EXIT GUIDE VANES

G. T. Smith  
Lewis Research Center  
Cleveland, Ohio

Prepared for the  
Thirty-fifth Annual Conference of the  
Reinforced Plastics/Composites Institute  
sponsored by the Society of Plastics Industries  
New Orleans, Louisiana, February 4-8, 1980

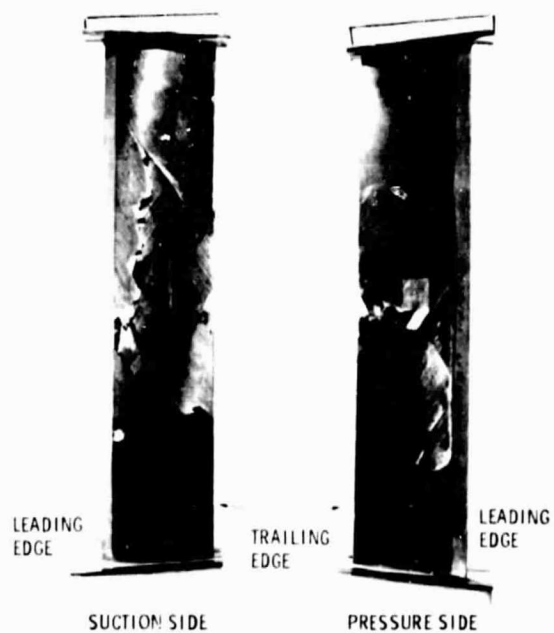
The exit guide vane operational experience, developed over 4600 hours of engine operating time in the JT9-70 engine, revealed a combination of deficiencies which resulted in inadequate structural durability. Figure 2 shows a typical failure encountered during those engine tests. A fatigue failure is centered at the midspan trailing edge of the vane and is clearly the result of excessive first bending mode deflections. Extensive delamination failure of the shell plys on the vane suction surface is present. The pressure surface displays somewhat less damage but the protective polyurethane coating has been peeled off and local chordwise cracking is evident from the midspan trailing edge to about the one third chord location. Figure 3 presents a photomicrograph taken of the vane cross section at midspan. The upper left hand detail shows indications of fiber contamination in the region near the vane trailing edge. Resin rich areas occurring where shell plys are terminated are also evident. The program which was funded by NASA was addressed to upgrading both the vane design and the vane manufacturing processes, and to a fatigue test validation of the revised vanes.

The failure mode experienced during the -70 model engine operations indicated that a reduction in the vane first bending moment deflections coupled with improvements in the physical characteristics of the composite materials were needed to attain adequate operational durability. Changes in both the vane design parameters and in the fiber treatment were made. The design parameter changes included both a change in the external vane contour and a change in the shell lay-up patterns. Figure 4 illustrates the revised trailing edge contour.

Figure 2. - Vane damage due to engine operation.

The trailing edge thickness was increased and the lay-up pattern modified to provide additional trailing edge stiffness. The modified lay-up pattern is compared with the original -70 model pattern in figure 5. The original thin trailing edge vane was characterized by termination of all shell plys in the trailing edge region. The revised design featured a trailing edge wrap around for the four outer plys resulting in a more continuous ply structure in this critical region of the vane.

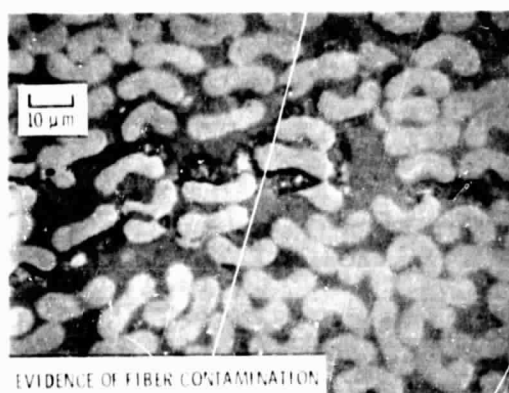
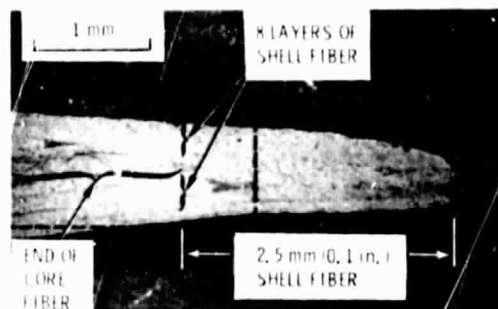
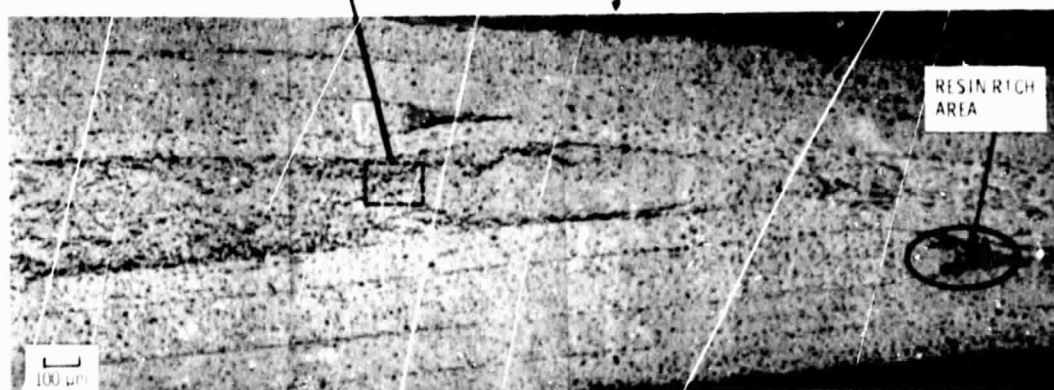
Figure 3. - Fabrication defects in early JT9D fan exit guide vanes.

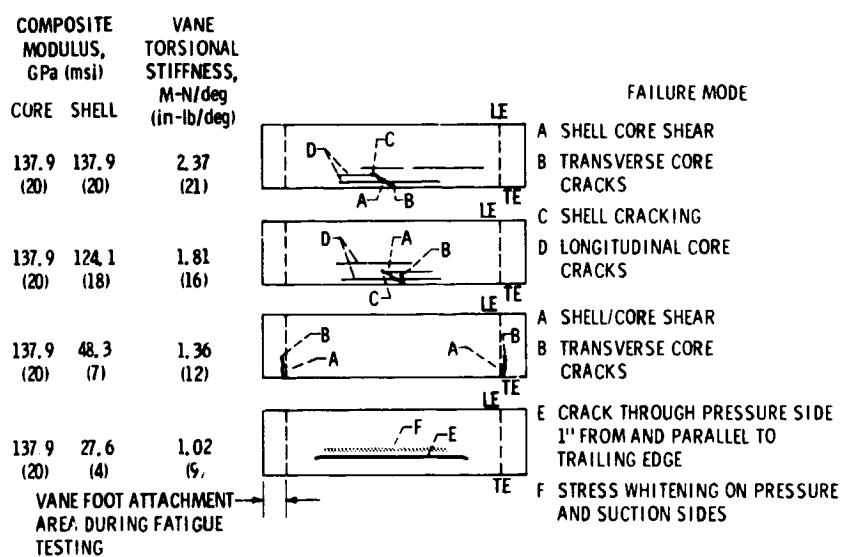
The failure modes experienced by the all-graphite and the graphite-glass shell vanes were different. Figure 13 indicates schematically the failure patterns developed during the vibratory fatigue tests. Both the all-graphite vanes (20 msi and 18 msi shell modulus) were characterized by midspan transverse cracking at the vane trailing edge. Longitudinal and transverse cracks in the core region were also present in both all-graphite designs at the midspan locations. Based on both visual and radiographic examination of the failed vanes, a failure sequence consisting of a shell-to-core shear failure followed by shell cracking, transverse cracking of the core, and finally, longitudinal core cracking was established as the most probable.

The two fiberglass shell vanes exhibited different failure modes than the all-graphite shell vanes. The highest modulus shell vanes, fabricated by TRW, failed transverse to the span at the vane attachment location. One vane of that group which had the lowest torsional stiffness, failed by a combination of

Figure 13. - JT9D composite fan exit guide vane failure modes.

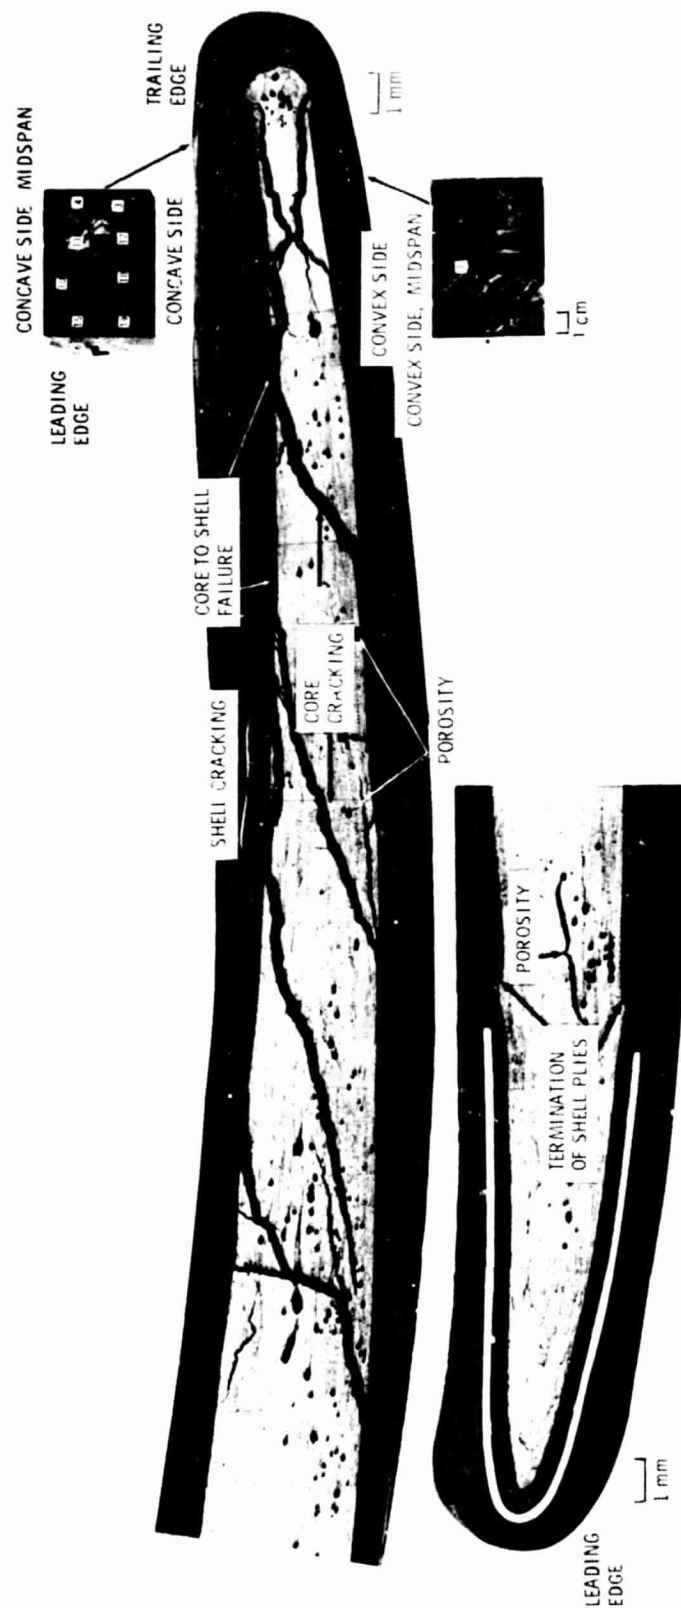
transverse core cracking at the trailing edge and radial cracking parallel to the trailing edge. Figure 14 presents a photomicrograph of the vane cross section which clearly shows the core cracking and core to shell delamination failures developed during this test. The two small inserts above and below the trailing edge section show the external appearance of the vane at the cross section location. The three stress whitened areas on the convex surface of the vane appear to correspond to the three cracks extending through the core in the photomicrograph.

Figure 14. - Photomicrograph of hybrid glass shell-graphite/epoxy core fan exit guide vane fatigue failure.

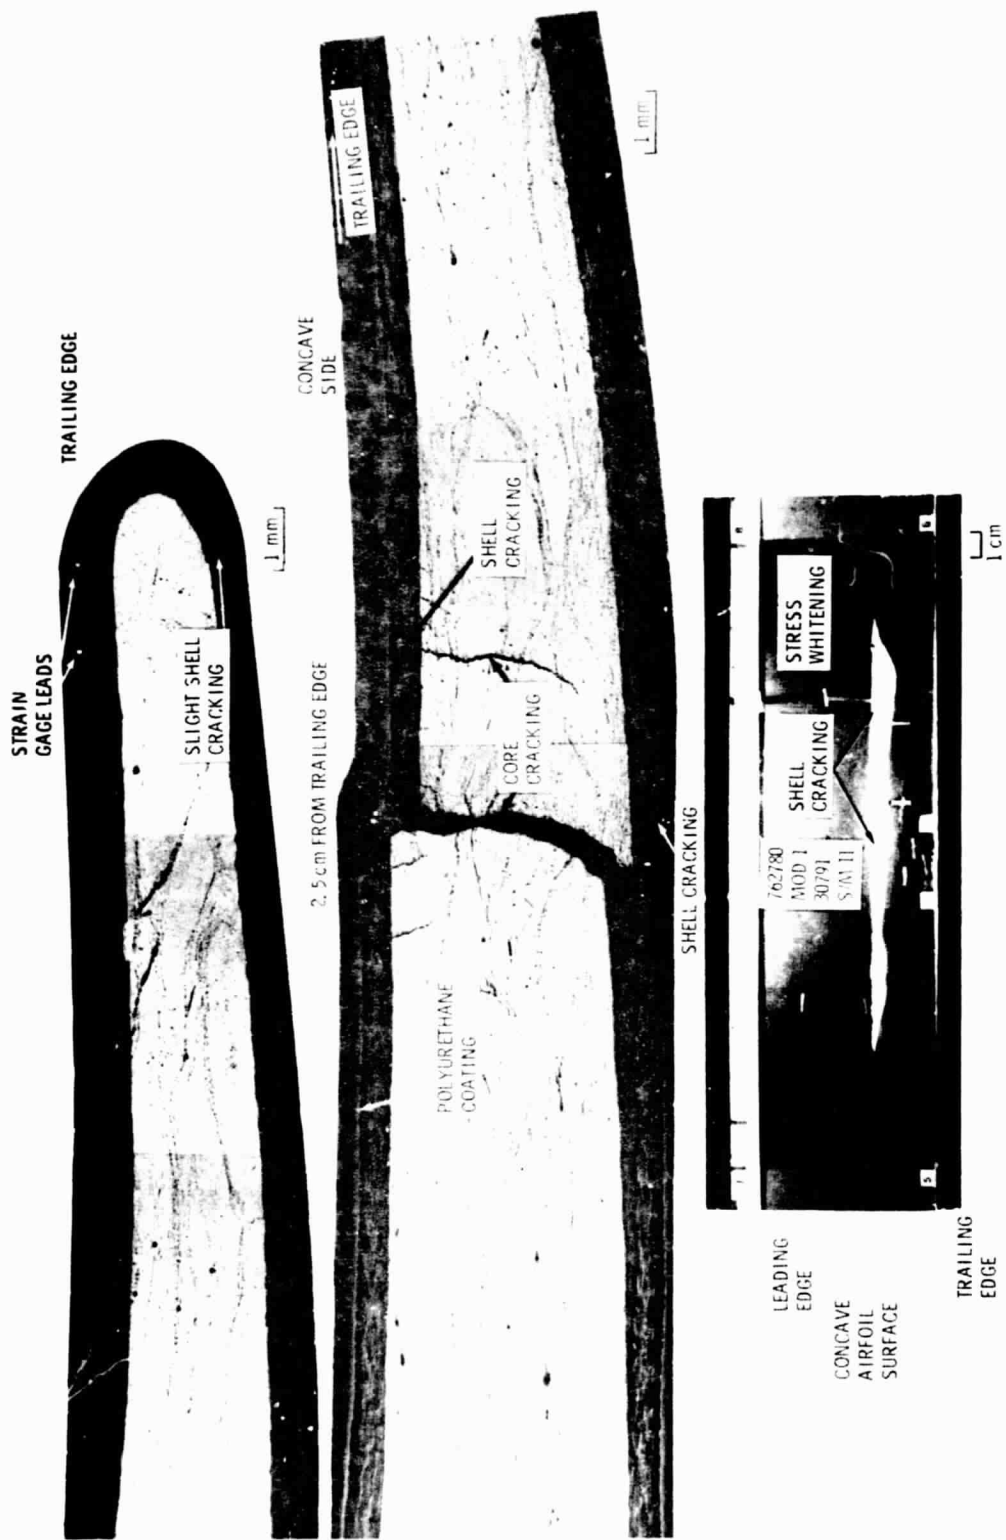
The other failure mode of the fiberglass shell vanes which involved longitudinal core cracking is illustrated in figure 15. The lower insert shows the very pronounced stress whitened region extending along the span parallel to and about one inch from the trailing edge. In this case core cracking was concentrated in one primary through crack and one secondary part thickness crack. Complete shell cracking is also apparent on the pressure (concave) side of the vane and extensive core-to-shell delamination is evident on the suction side of the vane.

Figure 15. - Photomicrograph of hybrid glass cloth shell-graphite/epoxy core fan exit guide vane fatigue failure.
